# Failure Investigation And Analysis

### Failure analysis of inner pipe leak in spool piece of jacketed pipeline

## Failure analysis of water-wall tube of boiler

## Failure analysis of heat exchanger tube

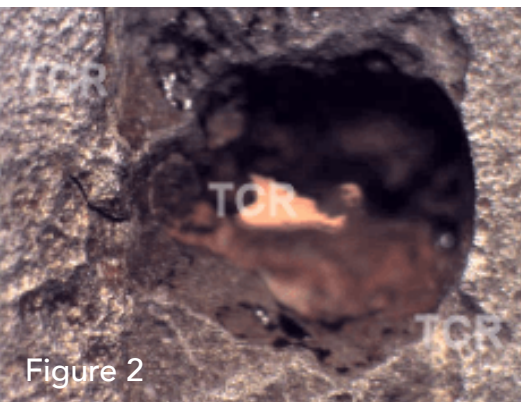
Figure 2 shows low magnification view at puncture on inner side weld. The puncture is by way of pit. The pit surface is dark brown in colour. Puncture contours towards OD are uneven.

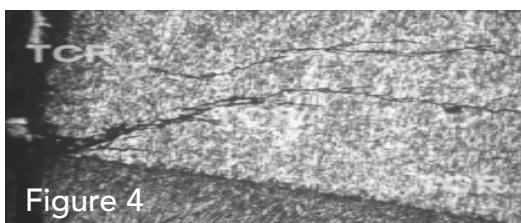
Figure 4 shows outer edge microstructures of weld and HAZ region which is worked austenite with scattered delta ferrite stringers. Transgranular cracks which are branched in nature are observed originating from outer edge. The crack is confined to the weld and HAZ.

The increased hardness and microhardness of the failed pipe indicates enhanced cold worked condition since manufacturing stage. The cold worked condition has adverse influence on the corrosion resistance. Thus, it is conclusive that pipeline used in PMV acid service was containing incompatible material of 304L spool piece that was susceptible to pitting corrosion. During the operation it failed by way of pitting corrosion and inter-dendritic corrosion at weld led to puncture.

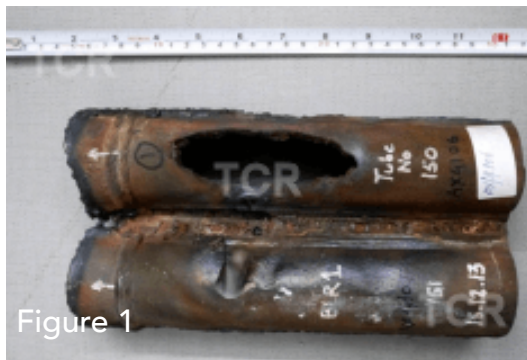
**DESCRIPTION OF FAILURE:** The window type rupture has taken place as primary failure on parent metal, and there was secondary nature of erosion failure on the adjacent tube.

Figure 1 shows the failed portion of water wall tube samples of tube no. 150 and 151. Tube no. 150 is having primary failure which is window opening type. Figure 2 shows rupture lip surface at some other location on one corner.

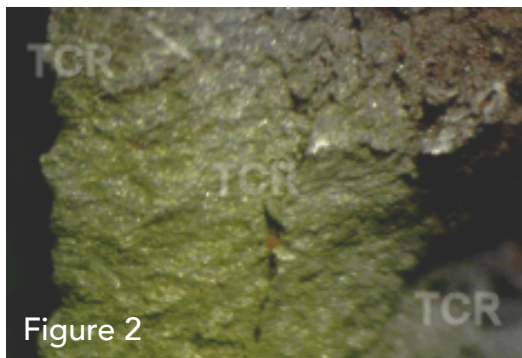
During failure the metal seems to have been partly caved out from the inner side of the rupture surface. Faint nuances of crack like discontinuities remaining present on the rupture lip which are towards inner side are indicative.

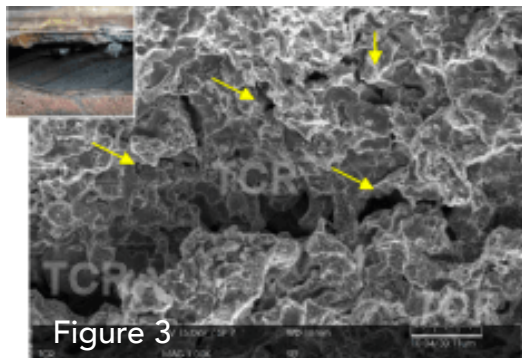
Fractograph of Inner edge of fracture surface rupture lip (Figure 3) indicates inter-granular nature of brittle fracture surface. Discontinuous fissures and grain boundary cracking is also seen (1000X).

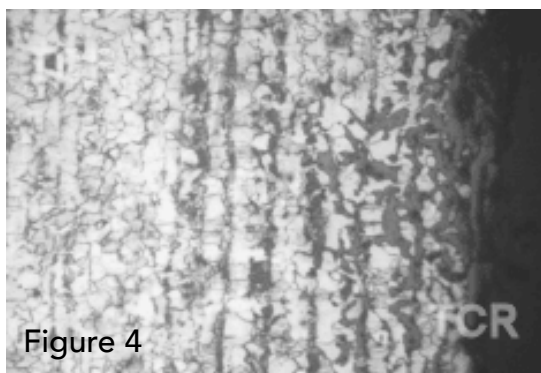
Figure 4 shows inner edge microstructure. Surface decarburization is noticed. Also, there is grain boundary fissures filled with scale and preferential attack on pearlite colonies. Inner surface is covered with porous scale (200X).

The failure of water wall tube is essentially due to hydrogen damage leading to formation of fissures and micro-cracks that weakened the tube matrix at failure location. The hydrogen damage occurred due to under-deposit corrosion at localized region.

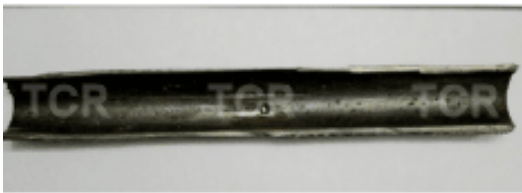
Figure 1 shows half portion of the cut tube having pinhole puncture that was received for investigation. Scattered pitting corrosion damage is noticed in longitudinal direction in line with the pinhole puncture.

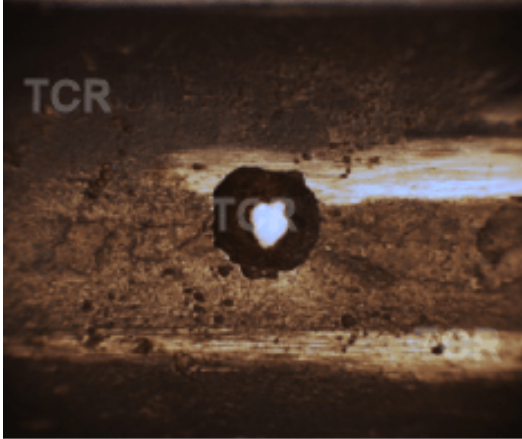
Figure 2 shows low magnification close up view on inner surface at puncture location. Puncture is conical in nature with decreasing cross section towards outer surface. The puncture surface is dark brown in color. The puncture contours are uneven but sharp and the surrounding area is free from any corrosion. On surface at away location, there are scattered shallow pits.

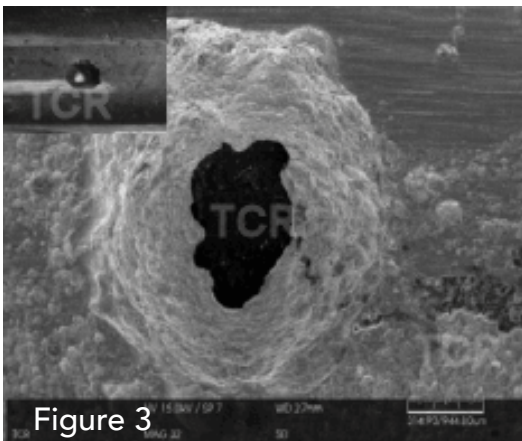
Figure 3 shows close up view at puncture location from inner surface. Area surrounding the puncture is heavily corroded. There is thinning at puncture contours.

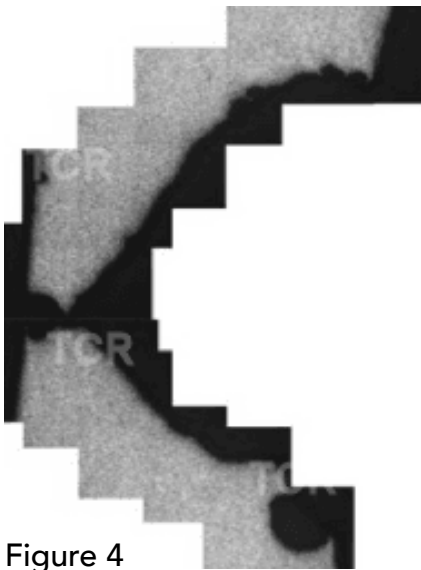
Figure 4 shows panoramic view of the puncture. Puncture is with large opening at inner edge which tapers down towards outer surface with non-uniform contours. There is slight increased opening on outer edge, this seems to be caused by corrosive fluid oozing out under slight pressure resulting into ventury like shape.

The premature puncture of the exchanger tubes appears to be on account of pitting corrosion damage which was under the influence of oxygen, moisture, sulphur and chloride ions as contaminants in the crude that was being carried.

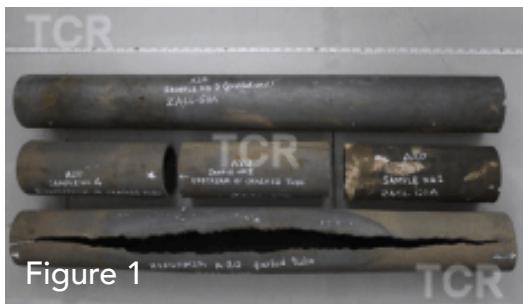
Figure 1 shows the photograph of reformer tube. The bottom most sample is cut portion having the crack area. In the middle the sample from left end side belongs to away from crack tip end marked with star. The middle one belongs to away from the crack tip marked with arrow. The one on right end belongs to inlet side. The one above is sample 5 from outlet end. The rupture has taken over the longer length up to approximate 1 meter length. Bulging is not observed except at the cracked region.

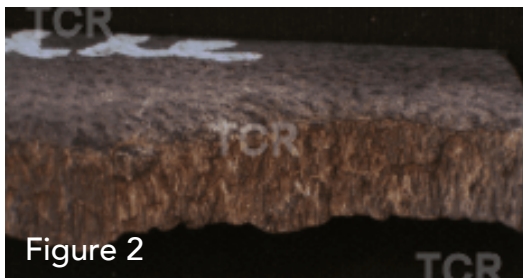
Figure 2 shows low magnification view of the fracture surface. The columnar nature of grain structure is highlighted on the brittle fracture surface.

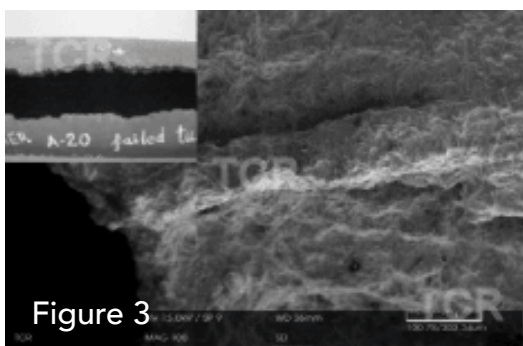
Figure 3 shows ID surface fractograph which highlights quasi cleavage nature of fracture surface, which is on the inter-dendritic columnar structure (100X).

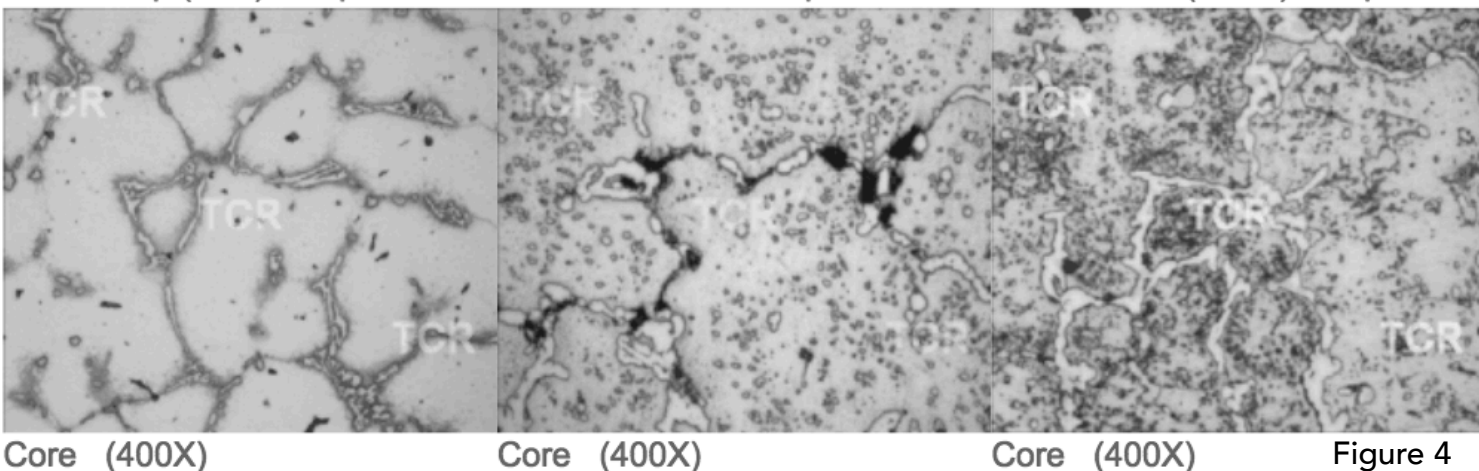
Figure 4

Figure 4. The top inlet sample shows primary carbides in the austenite matrix. Very few secondary precipitates are observed around inter-dendritic region. The failed region shows microstructure comprises of primary carbides at inter-dendritic region along with secondary precipitation including carbides within the austenite matrix. Presence of creep at primary carbides along with coarsening and coagulation of secondary precipitation and dissolution in the matrix. Bottom location microstructure shows coarsening of primary as well as secondary carbides at the inter-dendritic region as well as within austenite matrix. This location shows maximum coarse primary carbides along with higher density of secondary precipitations.

The failure of reformer tube appears to be on account of localized temperature excursions which resulted in extended creep damage due to microstructural degradations resulted in rupture..

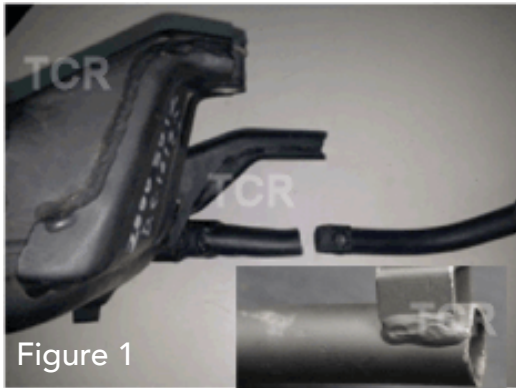
Figure 1 shows the photograph of muffler assembly with KZN exhaust tube. The failure has occurred nearer to the bracket location that has been tack welded to the exhaust tube. The failure is on the tube joining engine outlet to the silencer.

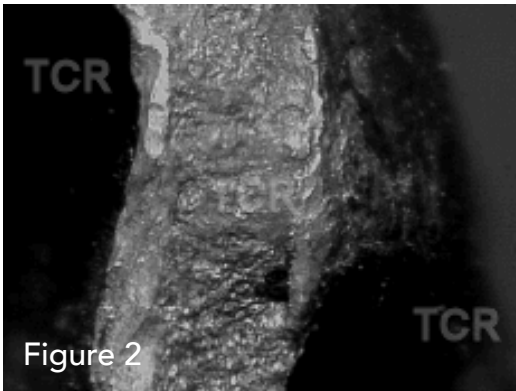
Figure 2

Light fractograph (Figure 2) shows conspicuous porosity and weld defect are observed (25X).

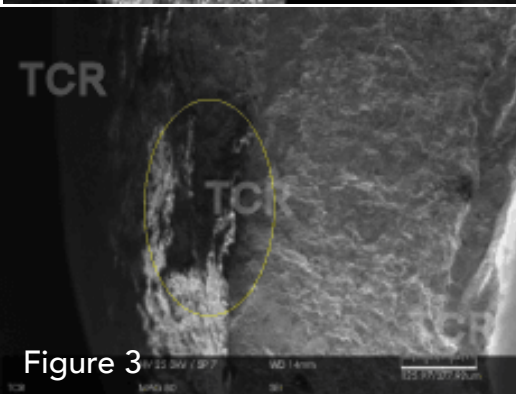
Figure 3

SEM fractograph (Figure 3) shows fatigue crack initiation at weld porosity from outer surface. Multiple ratchet marks are observed initiating from weld defect.

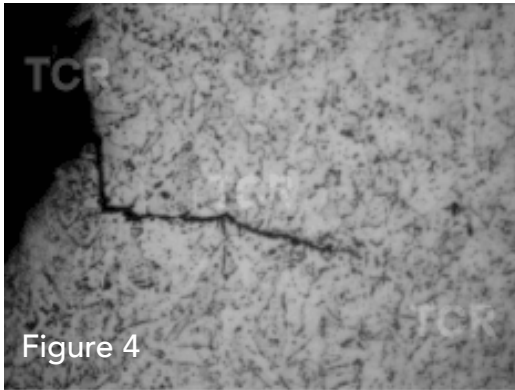
Figure 4 shows microstructure having ferrite and traces of pearlite with crack initiation from HAZ area (400X).

The premature failure of the KZN exhaust tube in muffler assembly is attributed to poor quality of welding done at the joint between the bracket and the tube. The welding defects coupled with HAZ with high hardness have initiated fatigue nature of failure.

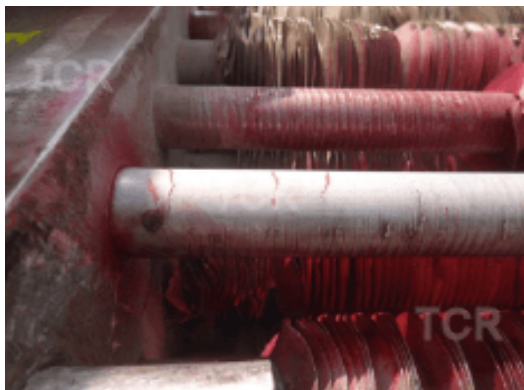
Figure 1 shows finned tubes that were damaged. Few tubes were shaved to look the damage.

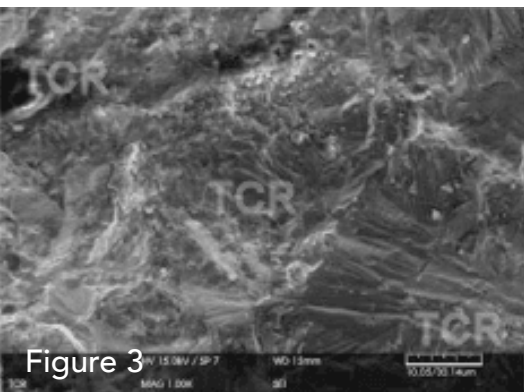
Fractograph by SEM (Figure 3) shows brittle nature of crack surface. Secondary cracks are also present on the crack surface (1000X).

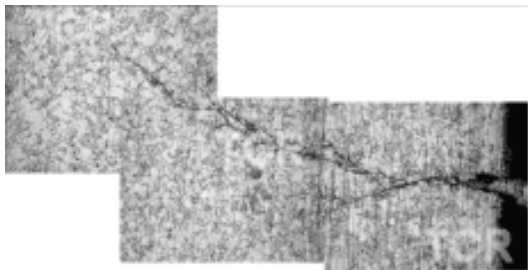
Figure 4 shows outer edge microstructure with trans-granular and branched cracking. Microstructure is worked austenite with twins (100X).

The premature failure of tubes of stripped coil overhead condenser is because of trans-granular stress corrosion cracking primarily from the inner side of the tube. Contamination of chlorine and moisture with the hydrocarbons passing through the tube shall be prevented.

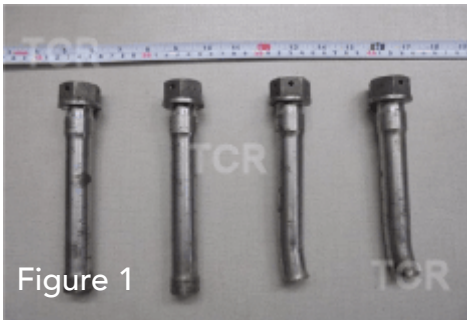
Figure 1 shows failed connecting rod bolts; all were found broken (bottom part in photo).

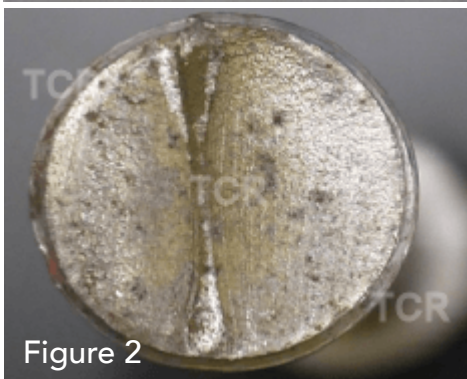
Figure 2 shows fracture surface shows large fatigue fracture surface from either end with small fast fracture surface in the middle portion.

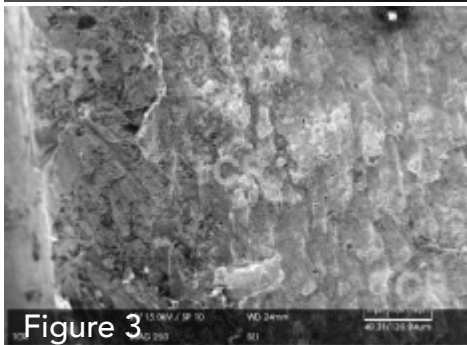
Fractograph by SEM (Figure 3) shows progressive nature of failure with beach marks locating the initiation on periphery (250X).

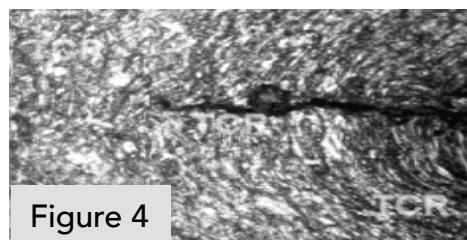
Crack is seen (Figure 4) with transgranular nature initiating from root, it is filled with scale. Microstructure is tempered martensite.

**CONCLUSION:** Connecting rod bolts failed due to wrong assembly of bolts during last overhaul that would have resulted in bolt looseness during subsequent operation.

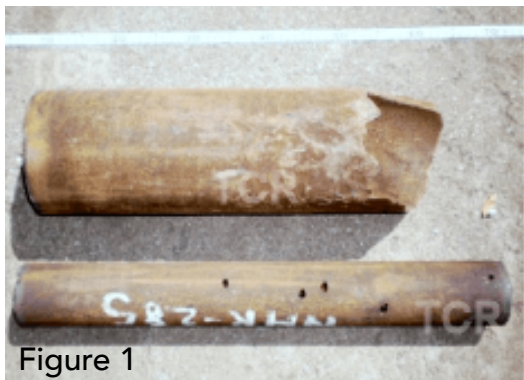
Figure 1 shows failed tube having puncture that was received for investigation.

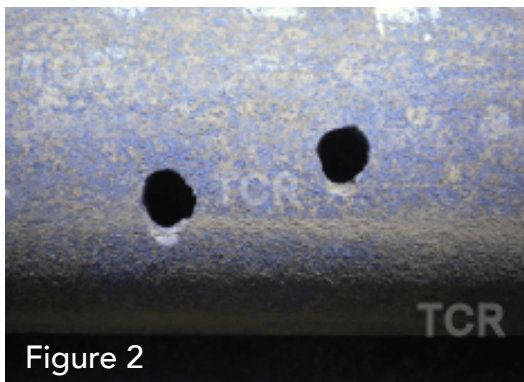
Figure 2 shows low magnification close up view on outer surface at puncture location.

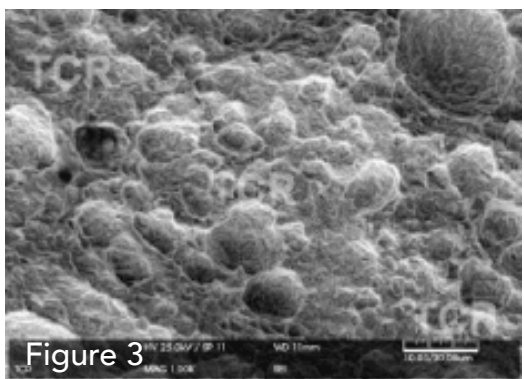
Figure 3 shows SEM image reveals micro level pitting corrosion damage from production side (1000X).

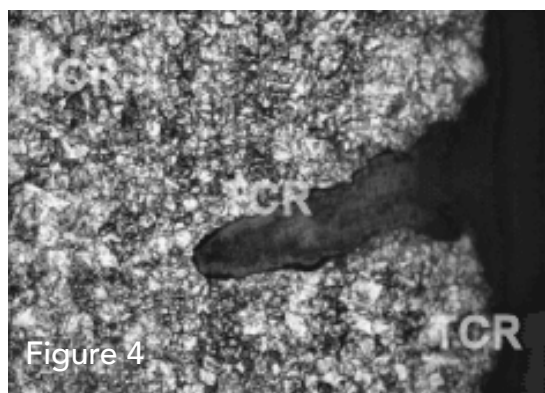
Figure 4 shows initiation of a pit filled with scales from ID side. The microstructure consists of fine tempered bainite structure (200X).

The production tubing was punctured due to pitting corrosion mechanism attributed either due to CO<sub>2</sub> corrosion during shut-in period or possibly because of use of contaminated/acidic CaCl<sub>2</sub> solution. Alternative killing fluid is suggested for intermittent services / stoppages.

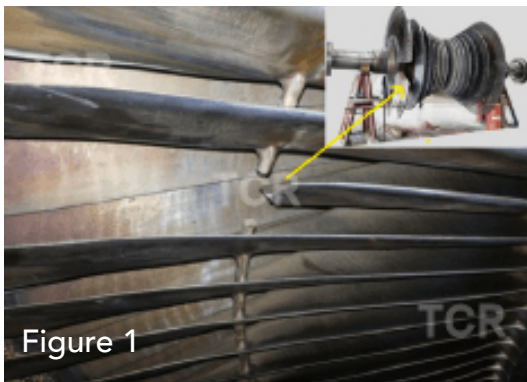
Figure 1 shows 430MW electrical power generation turbine with failed LP stage blade from snubber area

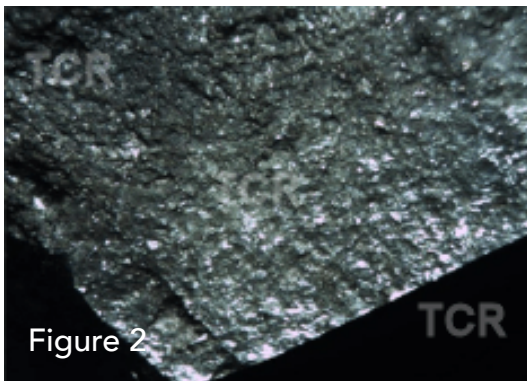
Figure 2 shows the Chevron marks indicate crack initiation from the leading edge near snubber portion.

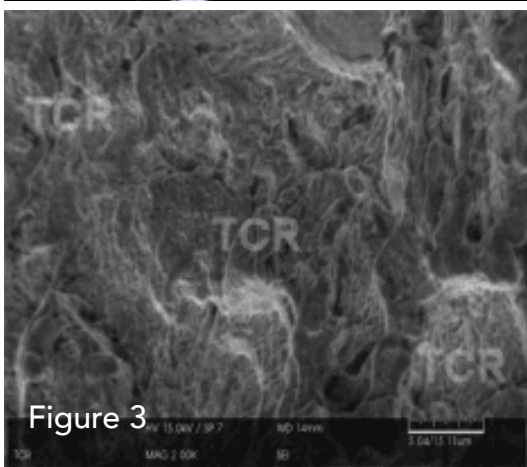
Figure 3 shows SEM fractograph of quasi cleavage nature of fracture surface (2000X).

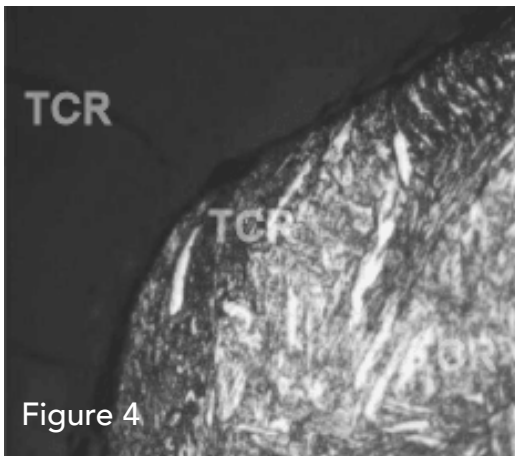
Figure 4 shows microstructure of fracture edge which has defatation. Structure is tempered martensite (400X).

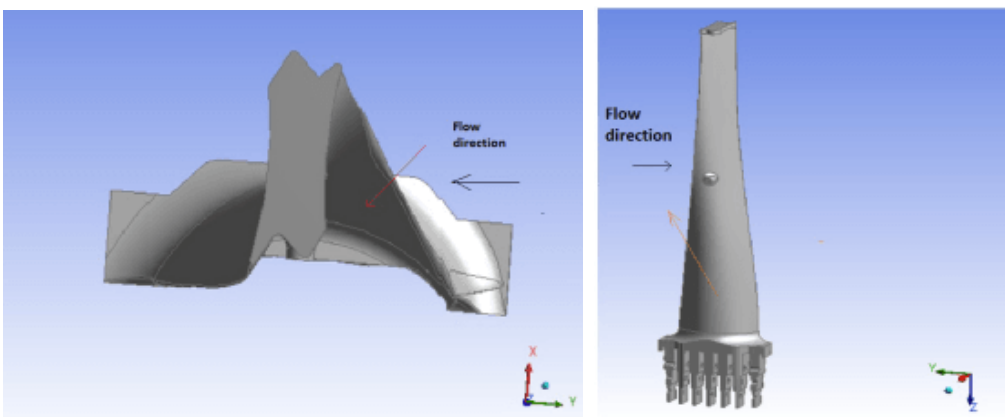
### Profile generation, post failure

Laser scanning and profile generation indicate stress raiser point below the snubber and towards leading edge which is the location of failure. Comparison between failed blade and generated profile shows lower sectional area at failed blade. Without have any significant effect on corrosion including opposite end blades, it suggests blades of improper machined profile.

The failure of last stage LP turbine blade appears due to use of lower thickness of blade that combined with sudden obstructions created by condensate built-up at the bottom which is not synchronized to be drained out. Use the blades as per designed thickness and profile is mandatory.

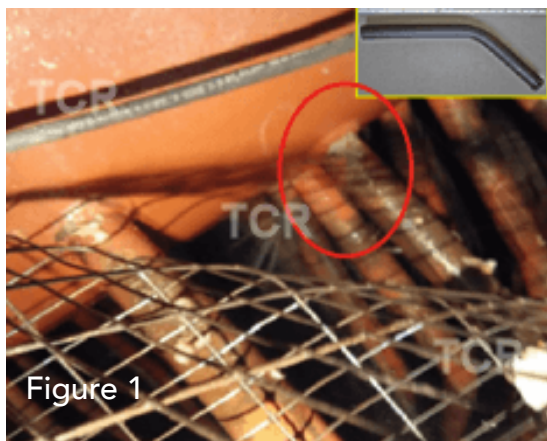
Figure 1 shows site photograph indicating area of failure.

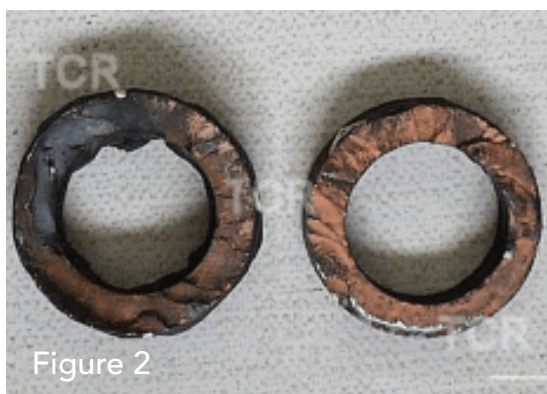
Figure 2 shows both parent metal and weld side fracture surface views. Both of them look relatively flat without any significant deformation. Weld side fracture surface is showing blackish nature on the inside.

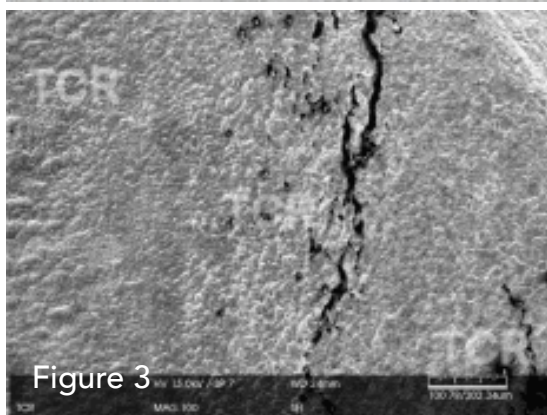
Figure 3

SEM fractograph (Figure 3) shows ID surface view near fracture. Quasi continuous cracks with irregular contours and fine tips are noticed. It is filled with oxide scale. There is fissure like opening surrounding the main crack (100X).

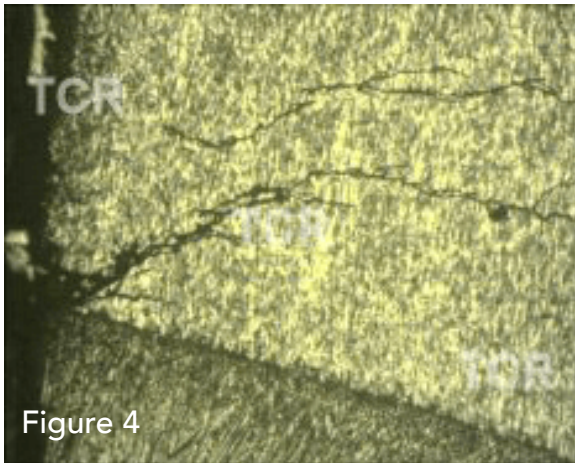
Figure 4 shows ID side HAZ microstructure showing intergranular cracking slightly branched in nature with fine tips. The contours are uneven. Microstructure is low- temperature tempered martensite (200X).

The failure of the superheater tube by way of cracking at weld between inlet header and tube is because of improper PWHT.
