Automobile Industry

CASE STUDY

Sector	Automobile
Category	Investigation on Failed Diesel Engine Valve

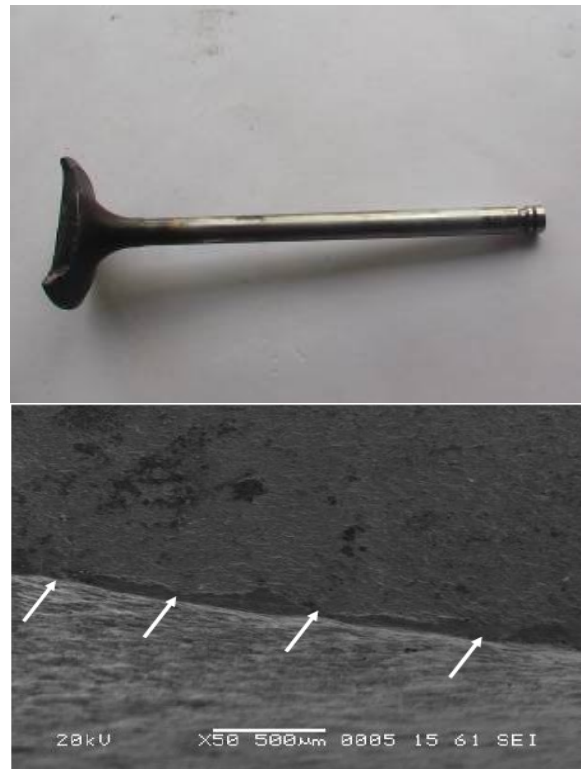
- Frequent valve failures in six cylinder diesel engine of 25 ton truck which is made of En-52 with medium carbon low alloy steel having Silicon and Chromium.
- The Failure was taking place on head and stem.

- The valve shall be properly hardened & tempered in order to achieve fully tempered martensite microstructure without any traces of ferrite
- The hardness shall be maintained in the stipulated range.
- Recommended to find out the source of sulfur and avoid the use of that fuel.

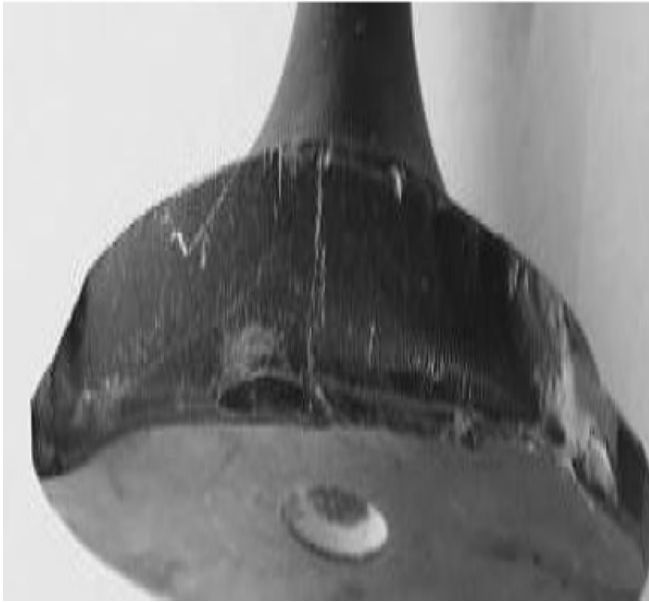
- The failure of the valve is due to corrosion fatigue cracking on account of improper heat treatment done which imparted poor mechanical & metallurgical properties.
