# Automobile Industry

## CASE STUDY

Category Investigation on Flange to pipe joint of front DSL muffler

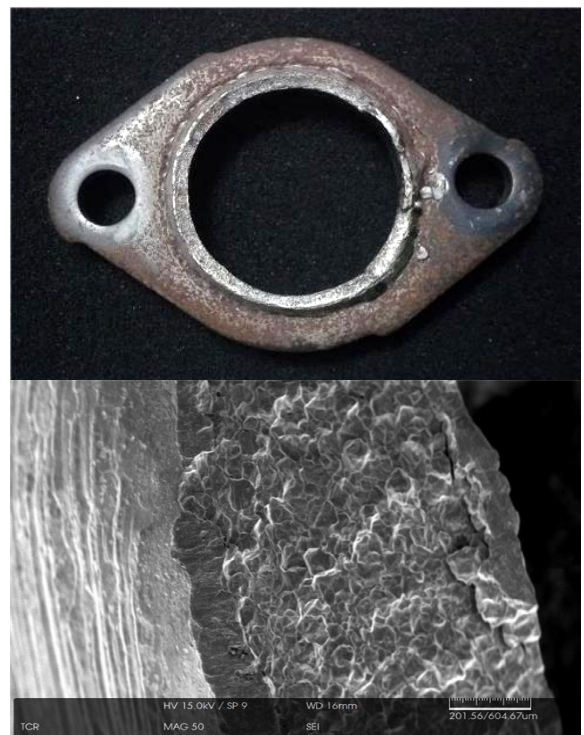
- Front muffler failure was observed after vehicle run of 5775km.
- During period of six months, four more failures have been experienced in the identical manner.

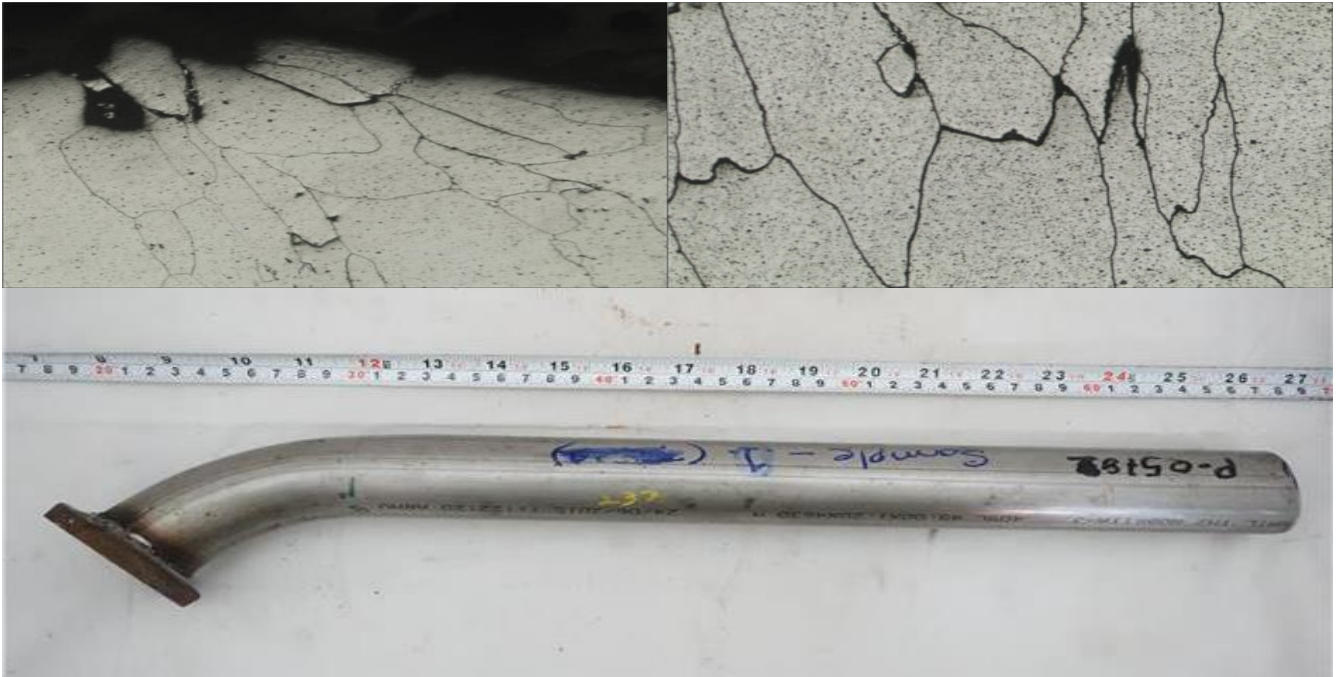
- The failure of muffler assembly from the weld joint between flange and the pipe is because of intergranular stress corrosion cracking due to sensitized condition of the weld and prevalence of corrosive environment.
- The weld microstructure shows sensitized condition
- The failure is in form of intergranular cracks, filled with scale along the weld between pipe and flange from ID side

- The metallurgical condition of both flange and pipe in terms of MOC, microstructure and hardness values is normal.
- The welding should be free from grain boundary carbide precipitation.
- The source of sulfur and moisture based contaminants needs to be identified and eliminated.
- Welding details of flange to pipe and its sequence may be examined for improvement to avoid distortion.
