Automobile Industry

CASE STUDY

Category Investigation on SKF NU217 Bearing

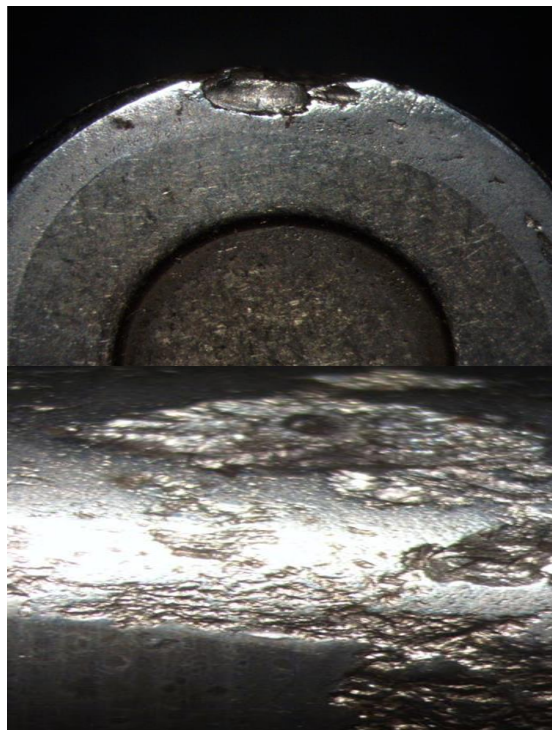
- During routine monitoring high vibrations was noticed on SKF NU217 bearing.
- Another Bearing of FAG NU1014.M1.C3 failed.

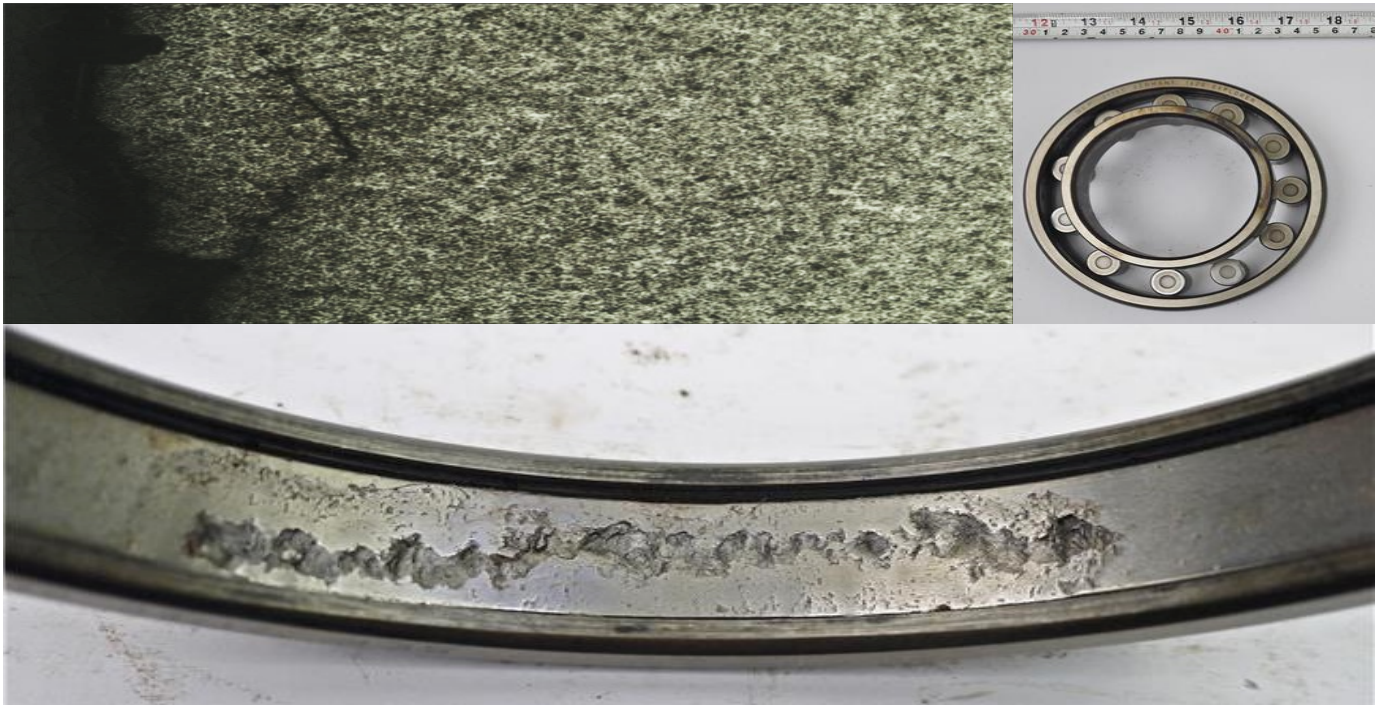
- Damage to the bearing components viz. outer race, inner race and rollers is because of rolling contact fatigue promoted by excessive shear stresses, likely to be caused by either misfit or poor lubrication quality.
- Scattered surface spalling on the working surface of the components is noticed along with acute angle sub-surface cracking at several locations.

- The bearing components metallurgy in terms of MOC, microstructure and hardness values appear to be normal.
- Lubricating parameters and quality of lube oil are required to be closely monitored.
- Meticulous care shall be taken while fitting the bearing such that there is no distortion or misalignment.
