Fertilizer Industry

CASE STUDY

Category Failure Investigation of stem with plug of LRCV 1201

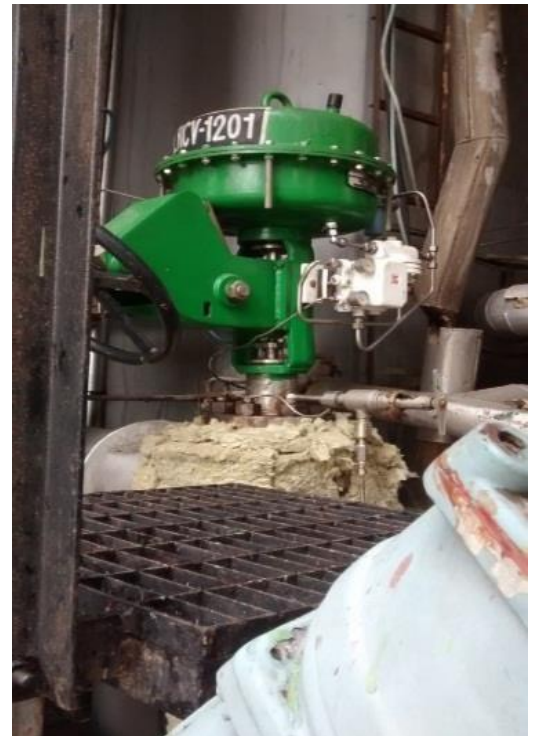
- A 4" angle level recording control valve-LRCV-1201 is located in the outlet line of H P Stripper (H-1201) in urea plant.
- The failure was noticed on 18th September, 2015 when the flow across the valve got stopped during operation.
- On inspection, we found that plug was separated from stem with fracture near radius at plug. The stem and plug are integral part.

- Design expert to be consulted for valve design review to overcome the possible failure modes explained in this report. Flow impingement of the stem needs to be eliminated with design improvements.
- The design expert to review if it would help by providing a chamfer on the valve seat which would convert the present line contact between plug and seat to a surface contact. OEM to be contacted.
- The design expert to review the flow direction for possibility of reversal; changing the flow direction from plug bottom that may aid in reducing vibrational loading and direct impingement of carbamate on stem.

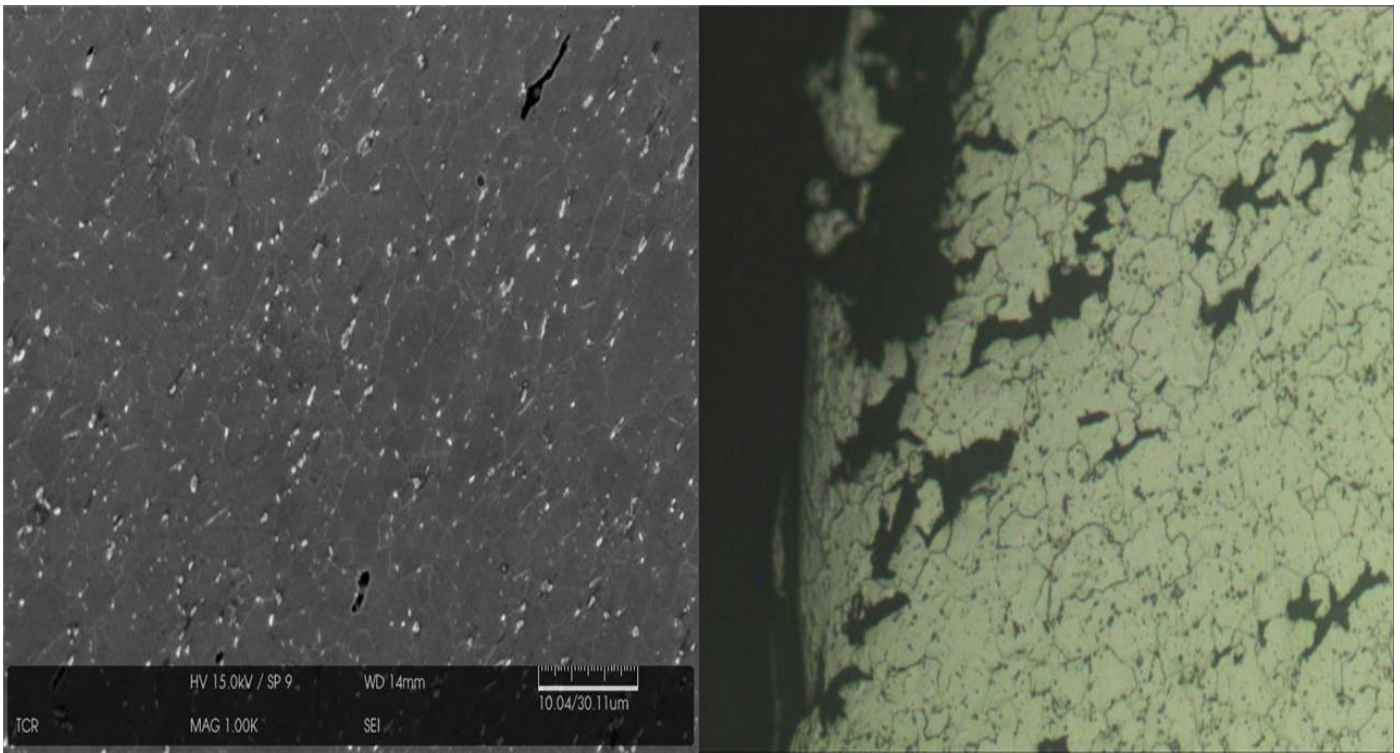
- The stem metallurgy is meeting with OEM specification.
- Change in MOC has not helped to solve the problem.
- Stem is exposed to erosion on carbamate facing side.
- The stem projection in carbamate flow path could be resulting in vibrations and hence cyclic stresses in stem would get exponentially aggravated with stress concentration area at radius zone having coarse machining marks and initiated cracking.
- The stem has fractured under mechanical fatigue mode and failed from vulnerable location.
