# Fertilizer Industry

## CASE STUDY

Category Investigation of Secondary Superheater Tube of Boiler

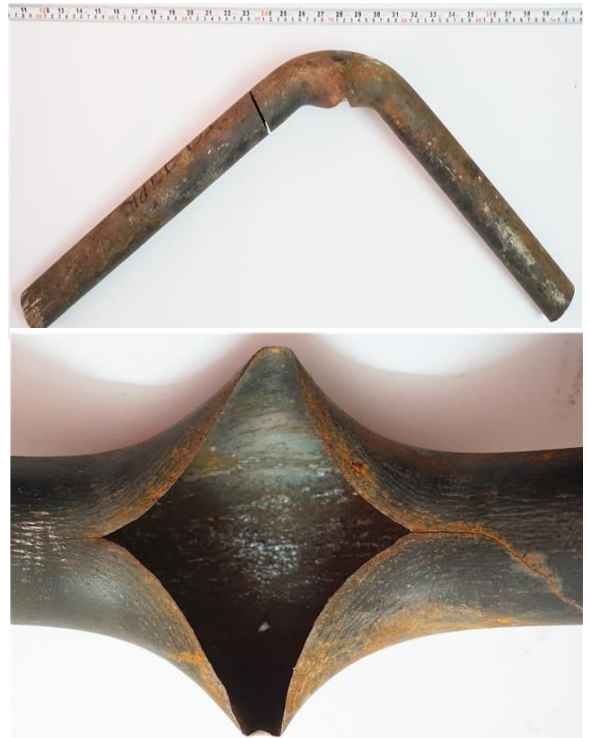
- Secondary superheater tube of panel failed by rupture during operation.
- The failure took place within one month from the commissioning of the boiler
- MOC of the tube is A213 grade T11.
