Fertilizer Industry

CASE STUDY

Category Investigation To Find Cause For Lower Hardness And Integrity Assessment Of Hp Steam Superheater Tube.

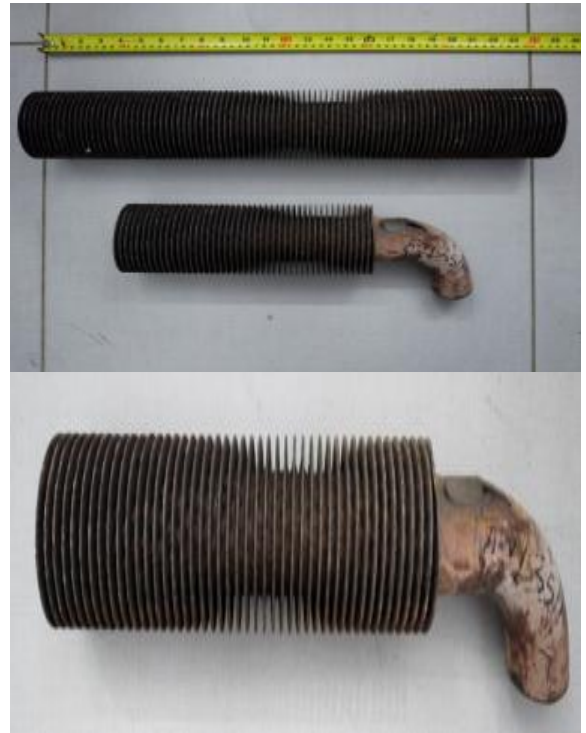
- Several instances of tube failures were reported since commissioning.
- At the time of inspection, one tube on inlet side was found twisted all along the length, and the fins were reported to have been overheated and oxidized.

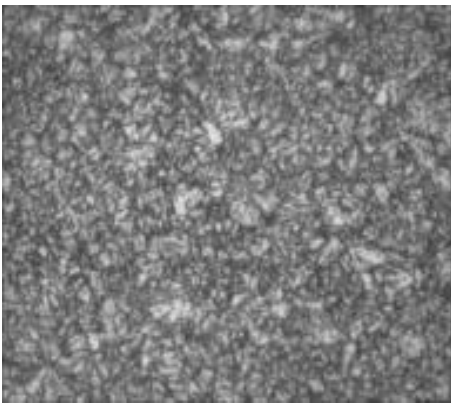
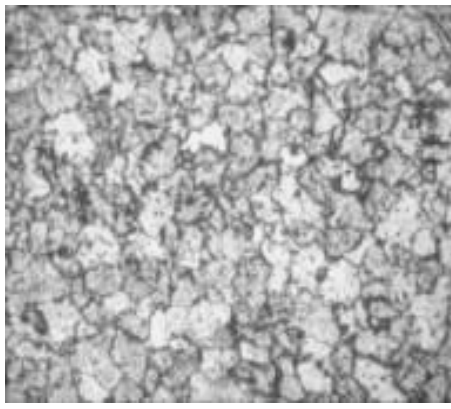
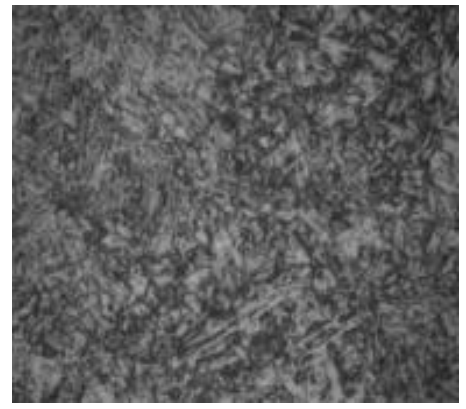
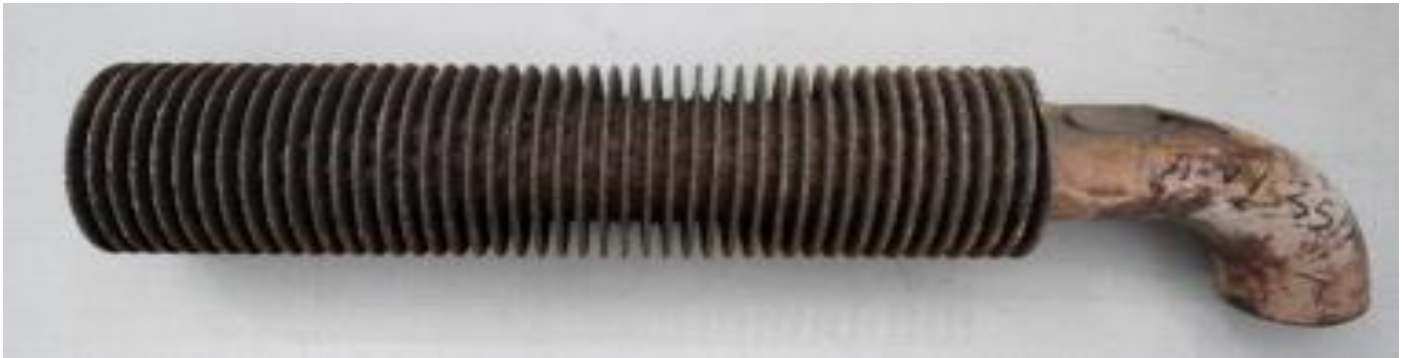
- The lower hardness on the straight portion of tube is limited to un-finned region. This seems to be from manufacture stage.
- The metallurgical integrity of tube is considered to be acceptable.
- The reason of repetitive failures may not be correlated to the present investigation.

- It is recommended to carry out hardness checking on rest of the tubes to ascertain whether there is any metallurgical degradation. On selected locations metallography may be conducted.
- As the condition assessment could hardly co-relate the leakage problem of the straight tubes in finned region, it is recommended to carry out a separate root cause failure investigation for the leakage problem. The corrosion crusts seen in visual and very high sulphur in EDS analysis accentuate its expediency.
