# Manufacturing Industry

## CASE STUDY

Category Investigation of Bearing Ring

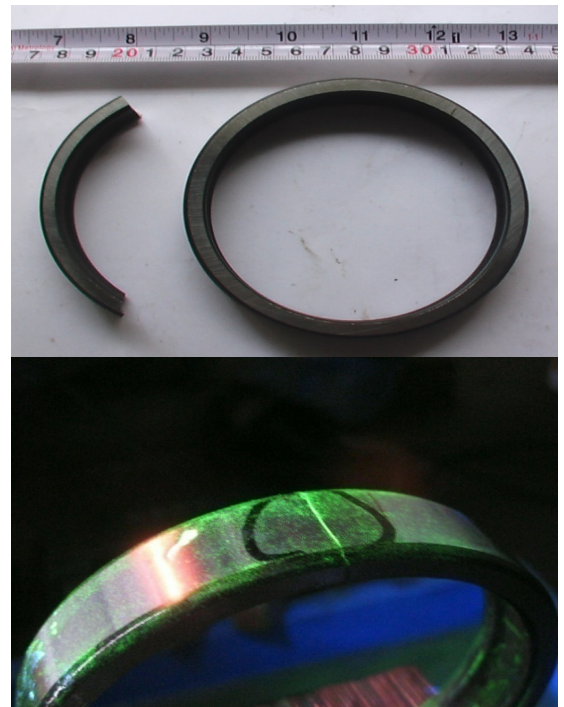
- A few pieces of bearing rings having identification no. AR 6212 was reported failing after final heat treatment of hardening and tempering. Four numbers cracked in one particular batch and this problem was faced for the first time.

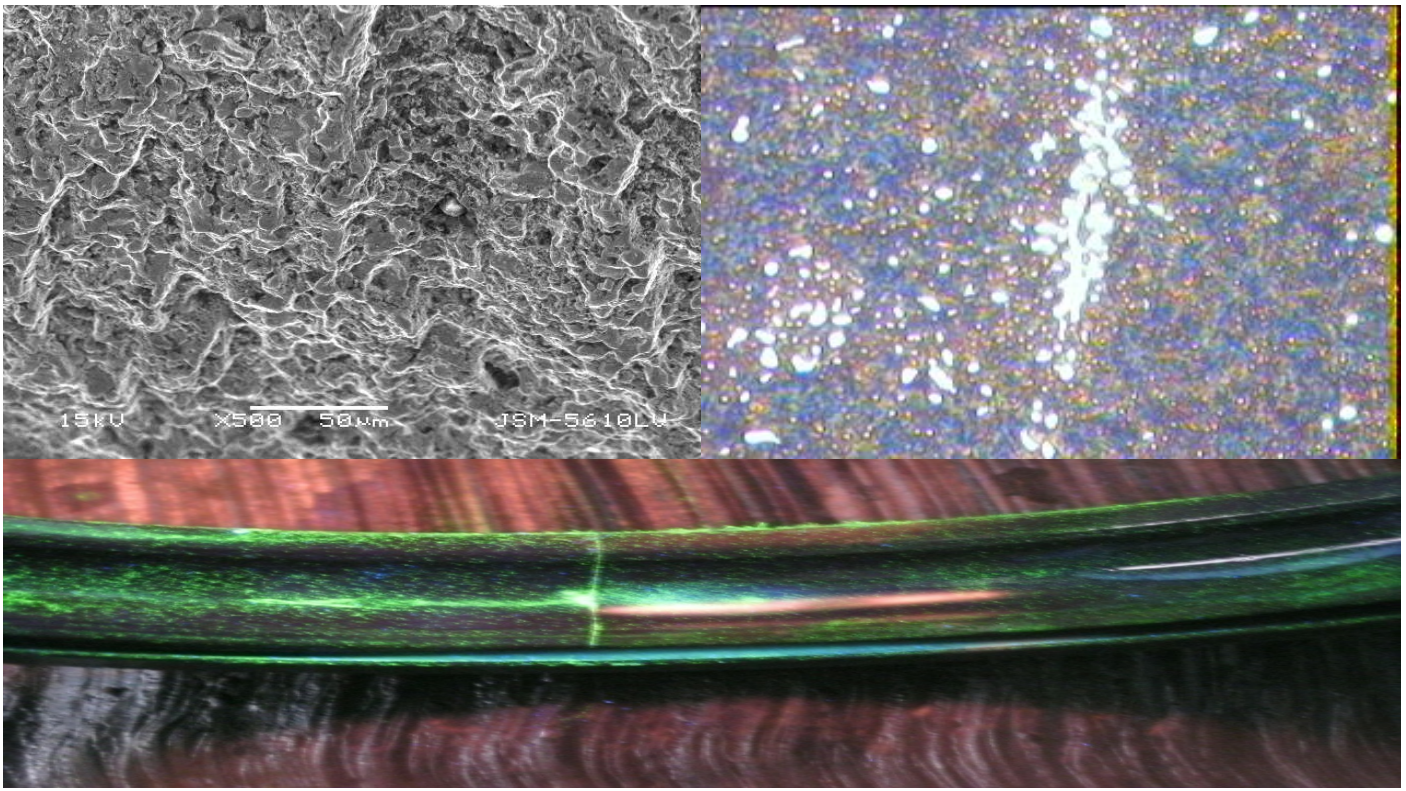
- Stray case of cracking of bearing rings during final heat treatment is on account of inadvertent presence of unforeseen micro level centre looseness in con-cast billet which had the concomitant segregation of carbides and other deoxidizing elements. Resultant carbides streaks and micro shrinkage acted as stress concentration sites during final heat treatment which promoted cracking.

- Since this is only a stray case, a little more precaution is required to be taken during NDT of the material stock, prior to forging.
- Since it is high carbon steel a little more discard has to be initiated from initial and end portion of the billets in con-cast sequence.
- The investigation points towards a little more precaution to be exercised in deoxidation, teeming and pit-side practices.
