# Failure Investigation And Analysis

### Failure analysis of inner pipe leak in spool piece of jacketed pipeline

## Failure analysis of water-wall tube of boiler

## Failure analysis of heat exchanger tube

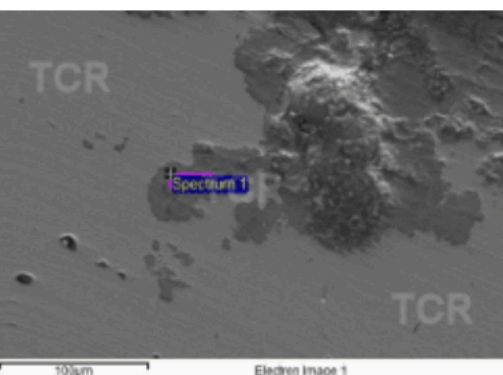
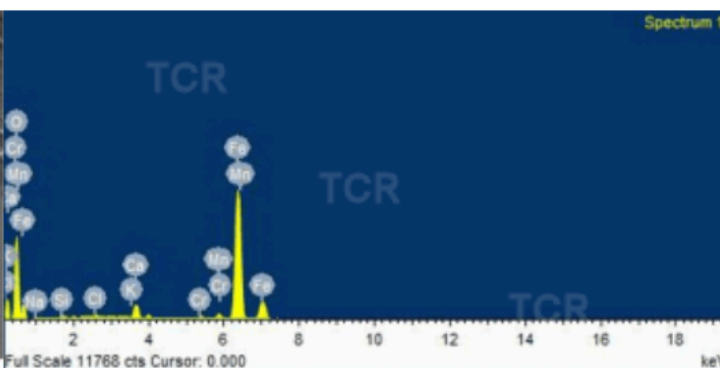
Figure 3 shows SEM image reveals micro level pitting corrosion damage from production side (1000X).

Figure 4 shows initiation of a pit filled with scales from ID side. The microstructure consists of fine tempered bainite structure (200X).

Element	Weight %
Carbon	12.48
Oxygen	12.94
Sodium	1.29
Silicon	0.46
Chlorine	0.45
Potassium	0.30
Calcium	0.86
Chromium	0.52
Manganese	1.87
Iron	66.84

The production tubing was punctured due to pitting corrosion mechanism attributed either due to CO<sub>2</sub> corrosion during shut-in period or possibly because of use of contaminated/acidic CaCl<sub>2</sub> solution. Alternative killing fluid is suggested for intermittent services / stoppages.
